Lawrenceville Plasma Physics, Inc

Focus Fusion Report September 18th, 2012

- New evidence for dense filaments
- Arcing solutions in sight

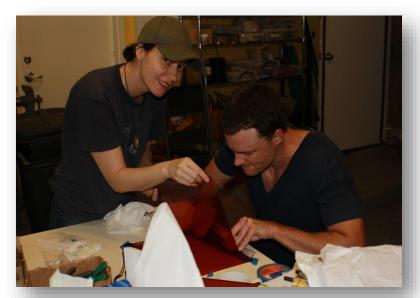
Ivana Karamitsos and Derek Shannon stack layers of adhesive kapton film, taking care not to create bubbles that would leave room for electrons to accelerate. These four layers of kapton are then cut and applied to the inner steel buss to protect the ceramic hat insulator from "feelers" of electricity that could lead to breakdown.
