LPPFusion Report

May 13, 2020

Anode Cracks; New Designs on The Way

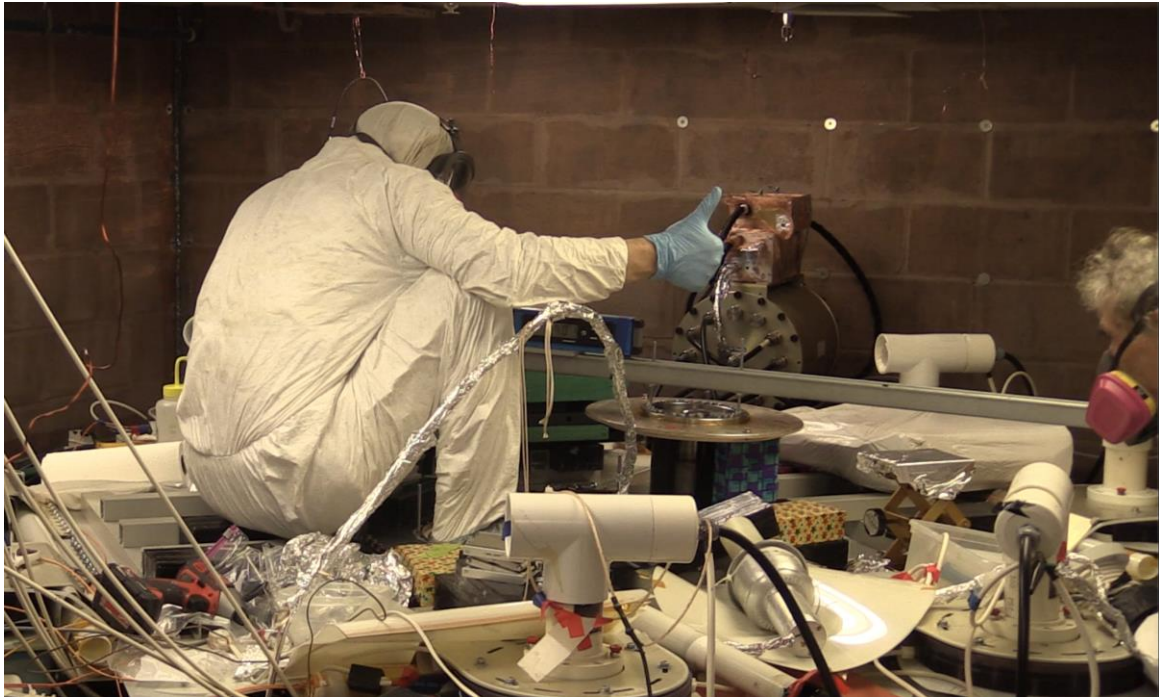
Fig. 1 LPPFusion Research Scientist Dr. Syed Hassan, fully protected against any release of beryllium dust, signals to Chief Scientist Eric Lerner the successful removal of the cracked anode (dimly visible under steel plate attached to steel beam).

The tricky part was to lift the anode vertically so it would not hit the surrounding ceramic insulator and crack that, too. There is only a 1 mm gap between the two parts. But Research Scientist Dr. Syed Hassan worked out a way to lift the anode with lab jacks and a level to guide a supporting rod. During the delicate operation on March 30, which we recorded, one jack collapsed. Fortunately, Dr. Hassan’s many lab skills include a quick reaction time, so he seized the supporting rod in time to prevent any damage to the insulator. (Fig.1) With Chief Scientist Eric Lerner assisting, Dr. Hassan successfully removed the anode and substituted an older steel plate with an O-ring as a temporary seal.

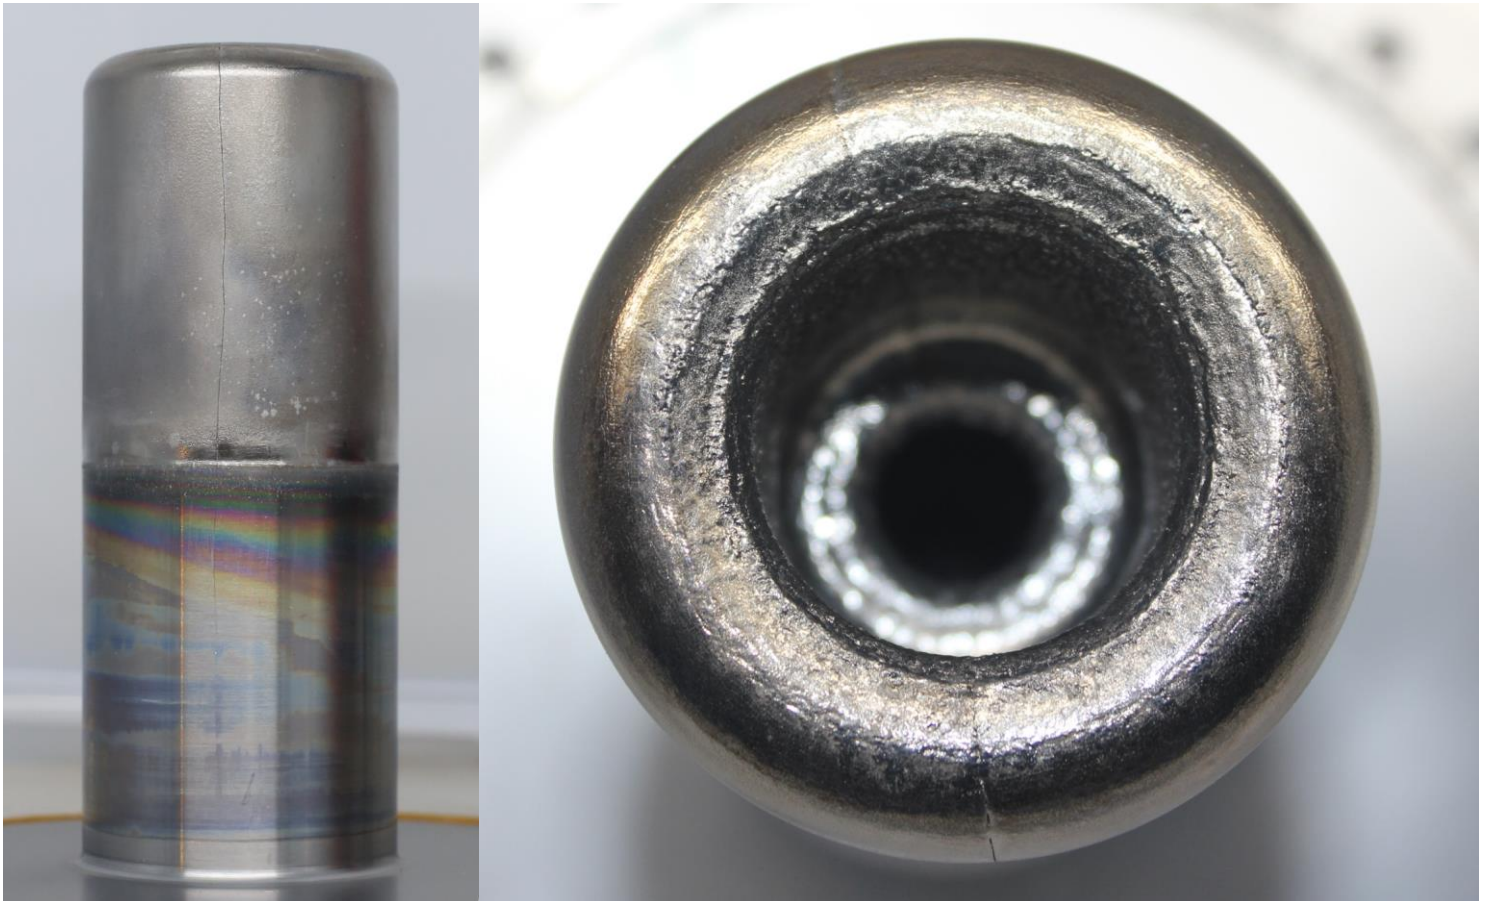
Fig. 2 Side view of anode shows one of two cracks extending down the sides. Top view shows two cracks, top and bottom extending out of the damage area on the inner lip of the anode.

Inspection showed two cracks running the entire length of the anode shaft (Fig.2). Initially, we suspected this might be due to mechanical stresses caused by the attachment of the upper vacuum chamber. But we saw no cracks on the base of the anode, where the upper chamber is attached. In addition, CAD simulations performed by LPPFusion Mechanical Engineer Rudy Fritsch showed that the stresses we had created were small on the base of the anode and negligible on the shaft. But if mechanical stress was not a problem, what could have concentrated stress to create these two cracks? The damage seemed to have originated from 100-micron wide cuts in the inner lip of the anode.

At this point, LPPFusion CIO Ivy Karamitsos pointed out that, since we had been so concerned for a long time about asymmetries in the current sheath, why couldn't these same asymmetries have led to the cracks? This seemed a good idea to look at. Lerner's calculations showed that a plasma filament with 100-micron diameter could vaporize the beryllium if it carried a current of more than 60 kA. A symmetric set of filaments would carry only 20 kA apiece, so would not cause the observed damage. But in a very asymmetric set of filaments, one filament could easily carry three times the average current.

This hypothesis explained how the cracks originated in small areas at the hollow end, or mouth, of the anode, where the current is at its most concentrated, and then propagated mechanically toward the anode base. The mild melting on the rest of the inner anode lip was consistent with what would be expected from an un-filamented sheath. There was also independent evidence for an asymmetric discharge. The deposits of beryllium on our two opposing windows were very different in shape and amount.

During this period, there were three likely causes, which probably had to occur in some combination to cause the damage. First there were several prefires, in which one switch alone fired, causing major asymmetries in current. Second, we had deliberately turned off the pre-ionization as a test. Pre-ionization smoothes the initiation of the current, and turning it off could have increased asymmetry. Finally, several of the shots were at low pressure, which also can lead to an uneven breakdown. In a couple of shots on October 29 all three conditions occurred simultaneously.

Fortunately, we are in a good position to prevent such cracks going forward. We have made major design changes to our new switches that will likely eliminate prefires. We will avoid in future shots turning off the preionization and firing at low pressures. In addition, the new anode we will be getting can be strengthened with design changes and annealing, a process of controlled heating to release strains caused during the machining of a part.
